Geophysical Investigation of Failed Portion (Km 2) along Iworoko - Are-Ekiti road, Southwestern Nigeria

Talabi, A. O., Akinola, O. O¹ and Adeoye, A. S.^{2*}

Abstract: The Iworoko-Are Road in Ekiti State, Southwestern Nigeria, has experienced persistent pavement failures despite repeated rehabilitation efforts. This study employs integrated geophysical methods to investigate the causes of the failures, focusing on the subsurface lithology, geological structures and soil properties. The research aims to provide actionable insights for sustainable road construction and maintenance in the study area. The investigation utilized dipole-dipole arrays method that combined horizontal profiling and Vertical Electrical Sounding (VES) and 2D electrical resistivity imaging to map the subsurface layers and identify the weak zones. The study also incorporated Electromagnetic method (EM) profiling to detect near-surface features such as fractures and faults. The geophysical survey revealed three to four geoelectric layers: topsoil (resistivity; 26.2–224Ωm), weathered layer (resistivity; 753 - 2543 Ωm), and fractured basement (resistivity; 75 -557 Ωm) and fresh bedrock (resistivity; 3,888 – 30,65

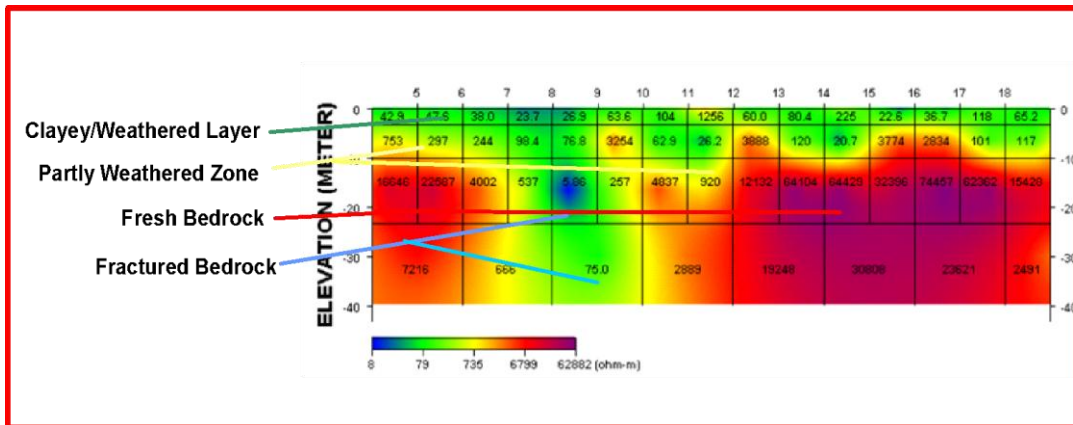
Figure 2: Electrical resistivity 2D-image structures

Figure 2 presents the subsurface resistivity profile along the 210 m traverse established over the failed portion of the road. The topsoil, characterized by clayey formations, extends to a depth of approximately 10 m across the study area. This layer exhibits resistivity values ranging from 26.2 to 224 ohm-m, indicating a highly conductive zone spanning the entire traverse from 0 to 210 m. The resistivity data reveal four distinct subsurface formations which are Clayey/weathered topsoil with resistivity values between 26.2 and 224 ohm-m, indicating a weak, moisture-retaining layer, partly weathered layer with resistivity values between 753 and 2543 ohm-m representing transitional material with moderate consolidation, fractured layer with resistivity values between 75 and 557 ohm-m, indicating structural weaknesses that could facilitate water infiltration and fresh basement which have a resistivity values between 3888 and 30,675 ohm-m, corresponding to competent unweathered bedrock.

A significant fracture zone is evident between 70 and 100 m along the traverse, extending to depths greater than 40 m. This fractured section correlates with the severely failed portion of the road and represents a high-risk area for further deterioration. If timely mitigation measures are not implemented, this could lead to total collapse of the road that may require substantial financial resources for reconstruction. Clayey subgrade and fractures compromise pavement performance by facilitating moisture buildup, lowering bearing capacity and triggering volume changes that can result in various structural failures.

The study revealed that the clayey topsoil, characterized by low resistivity (26.2–224 ohm-m), is moisture-retaining and prone to instability. A significant fractured layer, with resistivity values ranging from 75–557 ohm-m, was identified between 70 and 100 meters along the traverse and extending to depths exceeding 40 meters. This fractured section aligns with the most severely failed portions of the road, posing a high risk for further deterioration.

To address these issues, the study recommends reinforcing weak zones with appropriate engineering materials, particularly in the clayey and fractured areas, and improving drainage systems to prevent water infiltration. Additionally, sustainable construction practices that account for local geological conditions and regular geophysical surveys to monitor subsurface integrity are essential for ensuring the road's durability and resilience against environmental challenges.

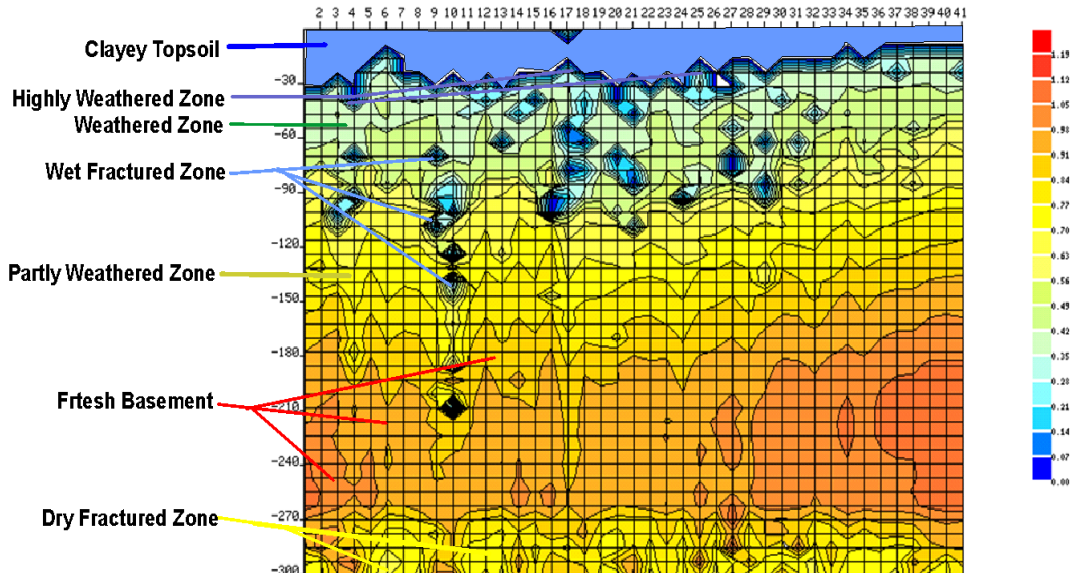
Figure 3: EM anomaly map of the study area along the single traverse

The electromagnetic survey delineated many formations, including clayey topsoil; a conductive layer that contributes to road instability, a weathered layer; which consists of moderately conductive zones indicative of partially decomposed materials, a partly weathered formation representing transitional zones with varying consolidation, a wet fractured zone characterized by saturated layer that weaken the subsurface and fresh bedrock which comprises highly resistive and competent zones at greater depths. Also, a dry fractured zone that lacks significant moisture is observed. The dry fracture zone still impacts the subsurface stability of the road.

The results reveal that the clayey topsoil extends across significant portions of the traverse, indicating its critical role in the road’s instability. The presence of the saturated fractured and weathered formations within the subsurface significantly weakens the mechanical integrity of the foundation, making it unable to withstand the downward forces from vehicular and heavy-duty lorry loads. The basement complex is the only competent zone with high bearing capacity that is ideal for road stability.

This method successfully probed depths of up to 300 m, providing a detailed understanding of the subsurface conditions. The 2D-geosection highlights critical weaknesses along the road; from 0 to 210 m with weaknesses evident at shallow depths exceeding 40 m. Additional responses indicating fractures and highly weathered formations are observed from 0 to 155 m along the traverse.

These findings underscore the importance of addressing subsurface weaknesses, particularly in the clayey and fractured zones, to improve road stability and durability. The Electromagnetic Survey corroborates the Electrical Resistivity survey as areas of the failed portion of the road are linked to low resistivity and geological flaws especially clayey and wet fracture zones. The stable areas generally correspond with higher resistivity and uniform

substrate; remediation requires removing unsuitable materials and installing competent fill and effective drainage systems.

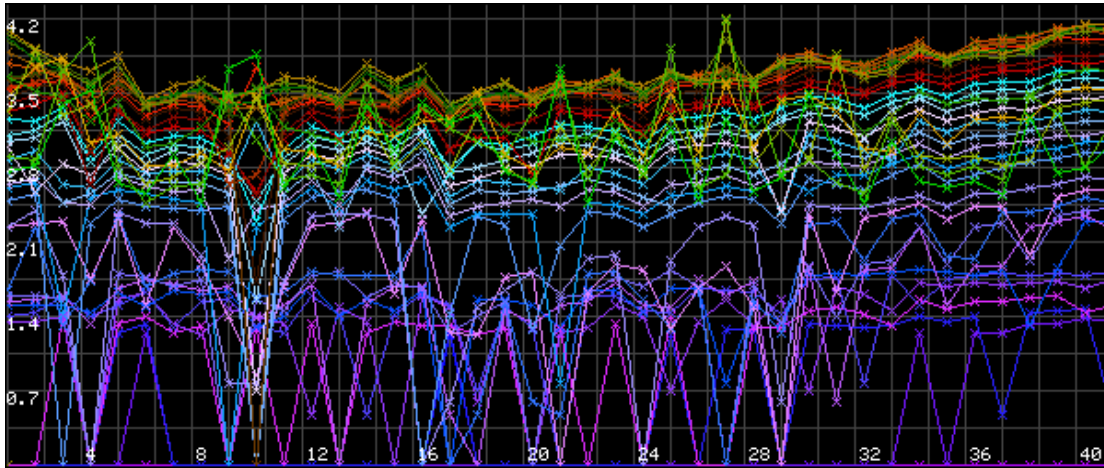
Figure 3: Profile plot at varying frequencies of the resistivity of the study area along the traverse

Profile responses of 19 varying frequencies of electromagnetic fields were analyzed to characterize shallow, medium, and deep subsurface formations. Fig.3 displays the frequency

response profiles of the electromagnetic fields, where low-response trends correspond to highly conductive zones, while high-response trends indicate highly resistive zones.

The electromagnetic profiles corroborated these findings, showing that highly conductive zones correspond to clayey formations and water-saturated fractures, while resistive zones indicate stable formations like the fresh basement rock (3888–30,675 ohm-m). The fractured and weathered formations, extending from 0–155 meters along the traverse, significantly weaken the road's foundation, particularly under heavy vehicular loads. The presence of saturated fractures exacerbates this degradation, making the subsurface unable to withstand downward forces, and without timely intervention, these weaknesses could lead to a total road collapse, requiring costly reconstruction.
